FIRST ARTICLE PREPRODUCTION TESTS OF THE AH - 64A HELICOPTER

NOVEMBER 1984

FINAL REPORT

UNITED STATES ARMY AVIATION ENGINEERING FLIGHT ACTIVITY
EDWARDS AIR FORCE BASE, CALIFORNIA 93523

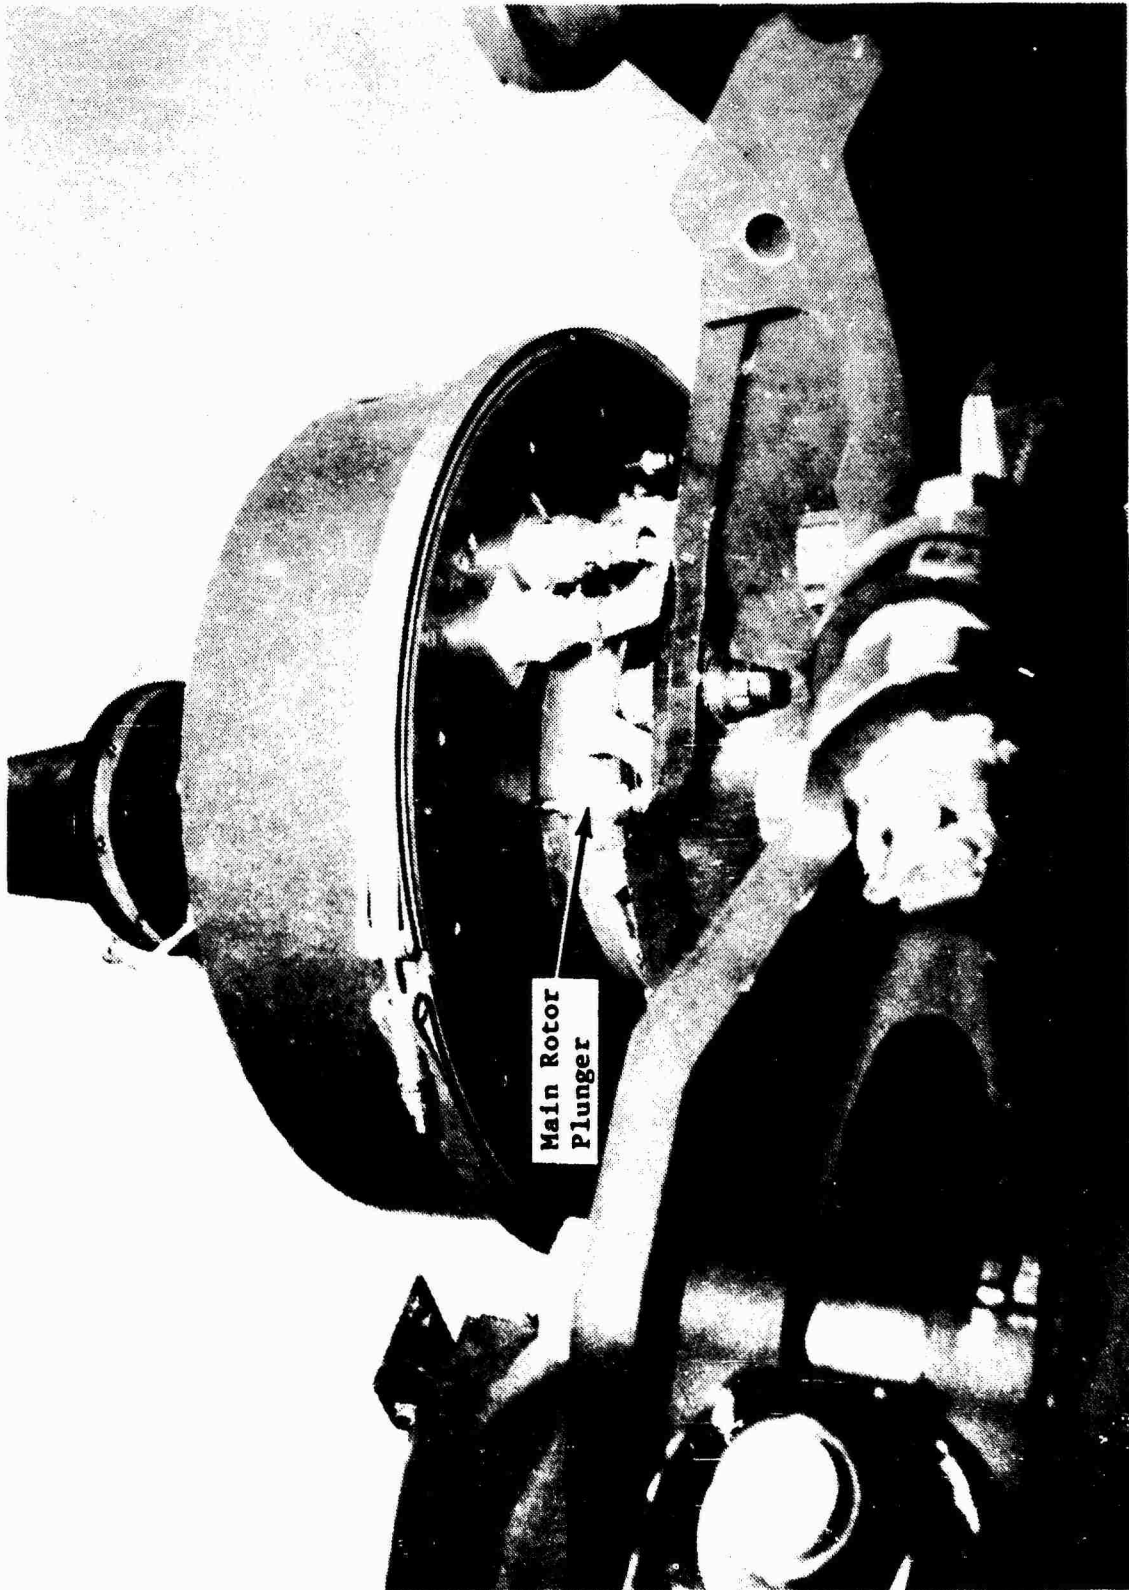
Photo 4. Main Rotor System

51. The main rotor system incorporated a plunger assembly (photo 4) designed to determine that the main rotor shaft nut and retention ring are installed. Presently, a daily special inspection procedure requires depression of the main rotor plunger. The reason for this inspection is not clear since the plunger does not indicate that there is torque on the retaining

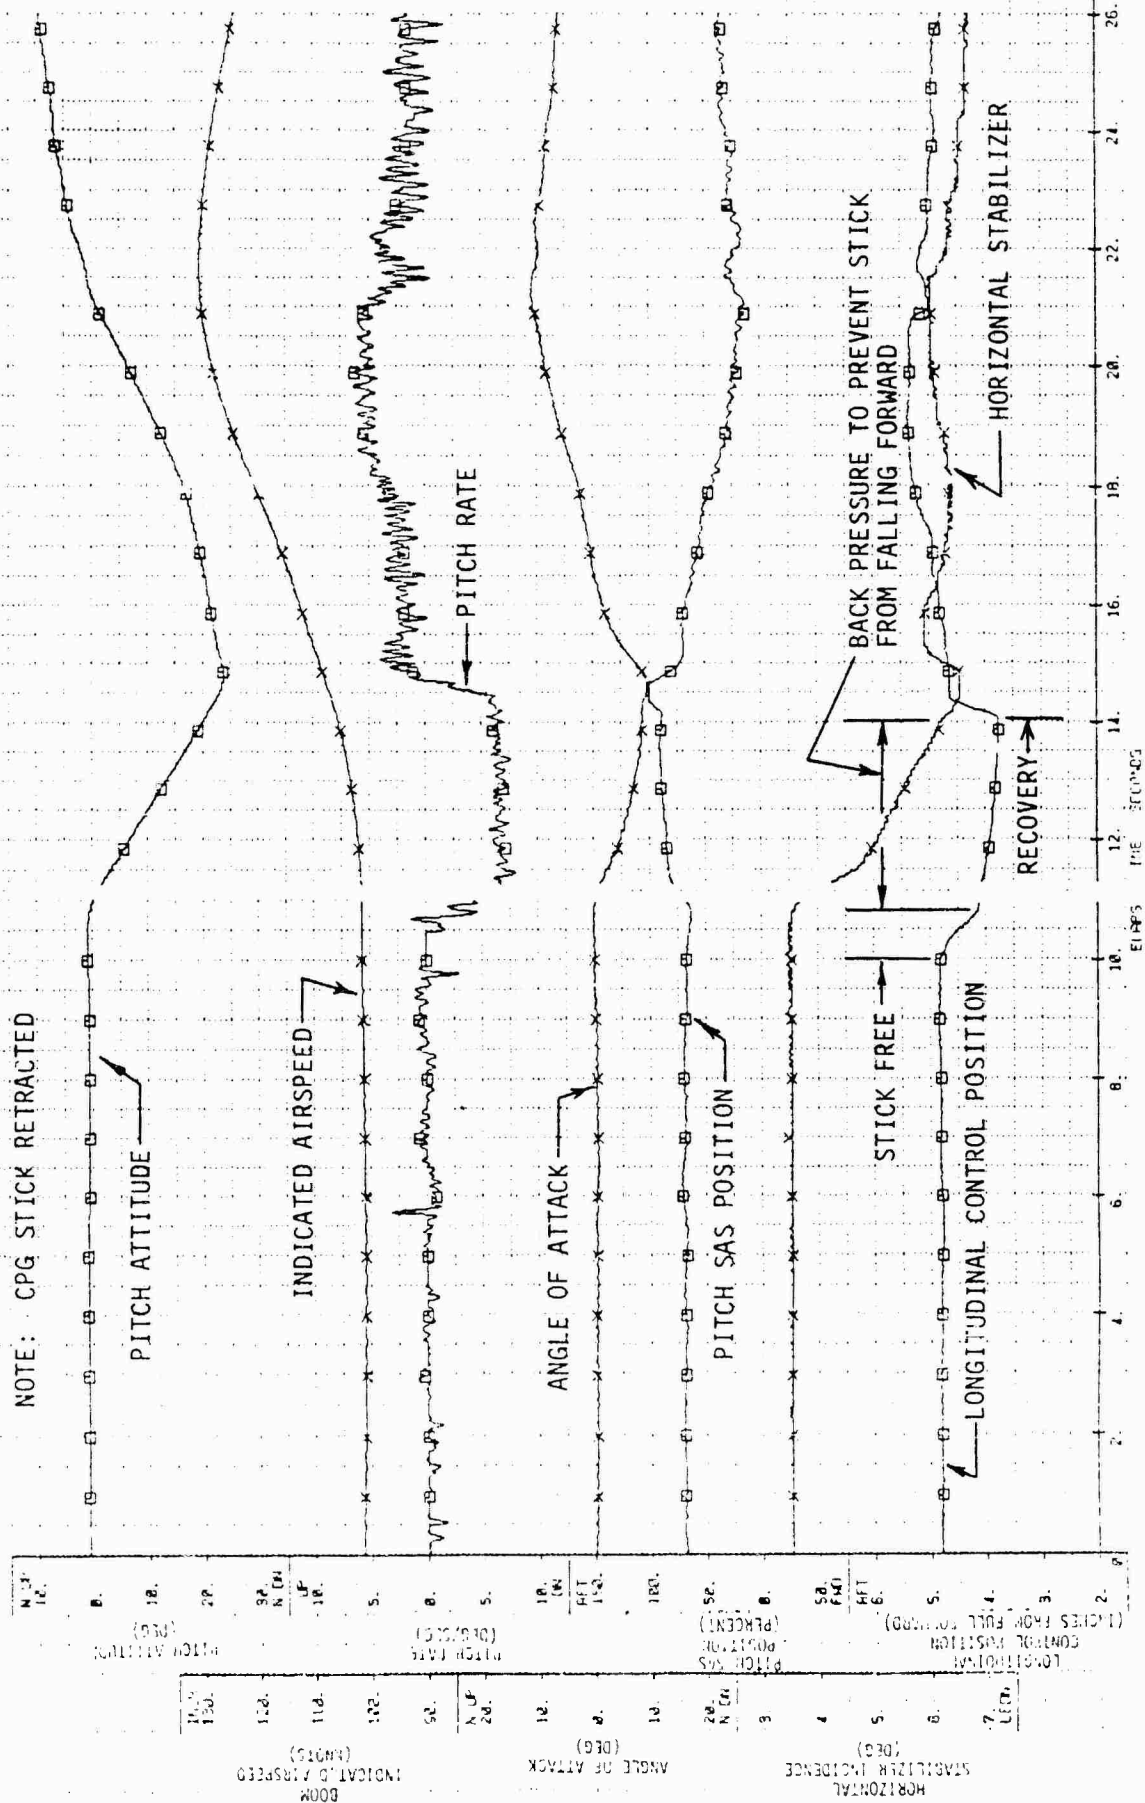
FIGURE 16
CONTROL POSITIONS IN TRIMMED FORWARD FLIGHT
AF-4A USA 57N 63-23355

16. Control positions in forward flight were evaluated in level flight, intermediate rated power (IRP) climb, and autorotative descent at the conditions presented in table 1. Data are presented in figures 16 and 17, appendix E. No variation of longitudinal control position with calibrated airspeed was found between 40 and 60 knots calibrated airspeed (KCAS) in level flight. Above 80 KCAS the gradient increased to 0.03 in./knot up to maximum level flight airspeed at intermediate rated power (V_H). The variation of lateral control position throughout the envelope was less than 1/4 in. Pitch attitude variation was essentially linear with increasing nose-down attitude with increased airspeed. In IRP climbs longitudinal control position was constant between 60 and 87 KCAS. Over 87 KCAS the control position moved forward with increased airspeed. In descent, longitudinal control position was constant between 60 and 75 KCAS, moved forward between 75 and 100 KCAS, and was approximately constant above 100 KCAS. The variation of lateral and directional control position was minimal throughout the airspeed range tested. Pitch attitude decreased slightly with airspeed in climbs and remained approximately constant in descents. Adequate control margins were available

throughout the conditions tested. The control positions in trimmed forward flight are satisfactory and met the requirements of paragraphs 10.3.3.1.2, 10.3.4.1.1, and 10.3.5.2.4 of the system specification (ref 1, app A).
